Living with the West Florida shore

Larry J. Doyle, Dinesh C. Sharma, Albert C. Hine,
Orrin H. Pilkey, Jr., William J. Neal, Orrin H. Pilkey, Sr.,
David Martin, and Daniel F. Belknap

Duke University Press Durham, North Carolina 1984
Property of CSC Library

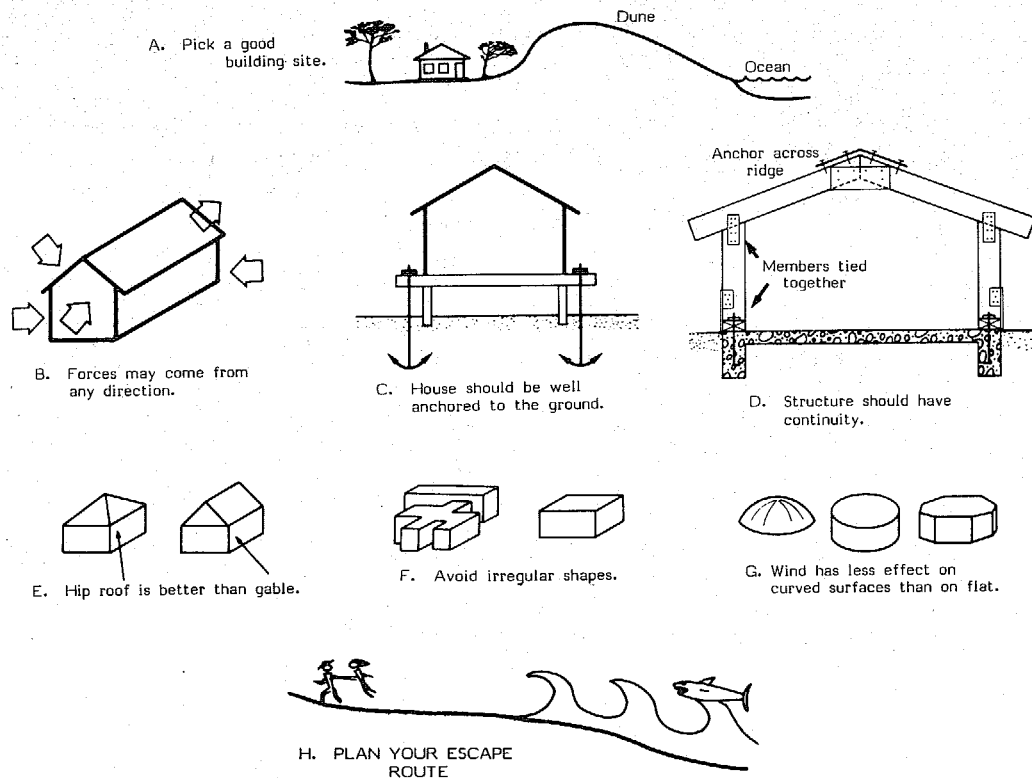
Fig. 6.11. Some rules in selecting or designing a house.

on a hexagonal or octagonal cross section is about 80 percent of that exerted on a square or rectangular cross section (fig. 6.11).

The design of a house or building in a coastal area should minimize structural discontinuities and irregularities. It should be plain and simple and have a minimum of nooks and crannies and offsets on the exterior, because damage to a structure tends to concentrate at these points. Some of the newer beach cottages along the Florida shore are of a highly angular design with such nooks and crannies. Award-winning architecture will be a storm loser if the design has not incorporated the technology for maximizing structural integrity with respect to storm forces. When irregularities are absent, the house reacts to storm winds as a complete unit (fig. 6.11).

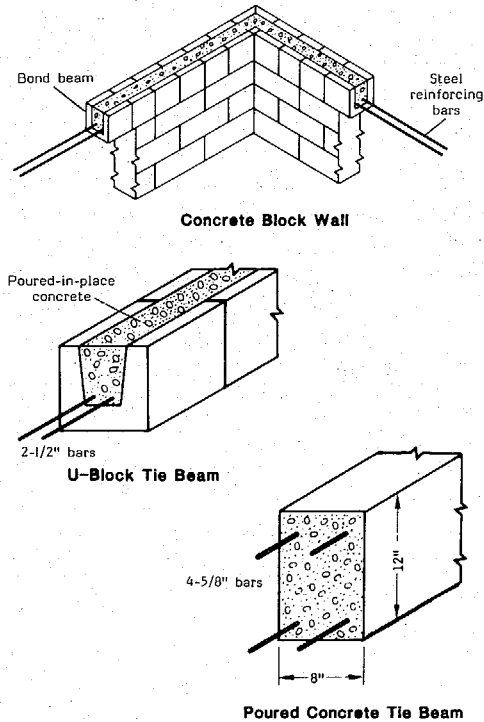
Fig. 6.12. Reinforced tie beam (bond beam) for concrete block walls—to be used at each floor level and at roof level around the perimeter of the exterior walls.

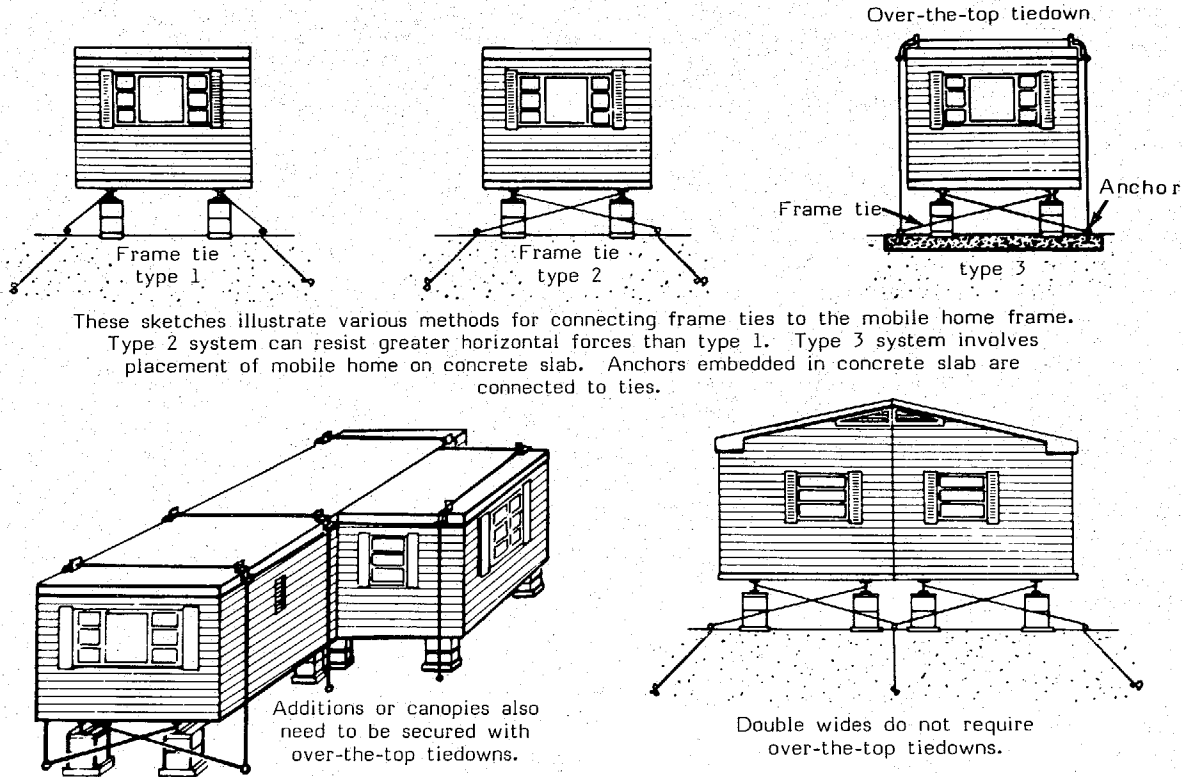
Fig. 6.13. Tiedowns for mobile homes. Source: U.S. Civil Defense Preparedness Agency Publication TR-75.

tems. See figures 6.13 and 6.14 for illustrations of how ground anchors can be used.

A second lesson taught by past experience is that the mobile home must be tied down or anchored to the ground so that it will not overturn in high winds (figs. 6.13 and 6.14 and table 6.1).

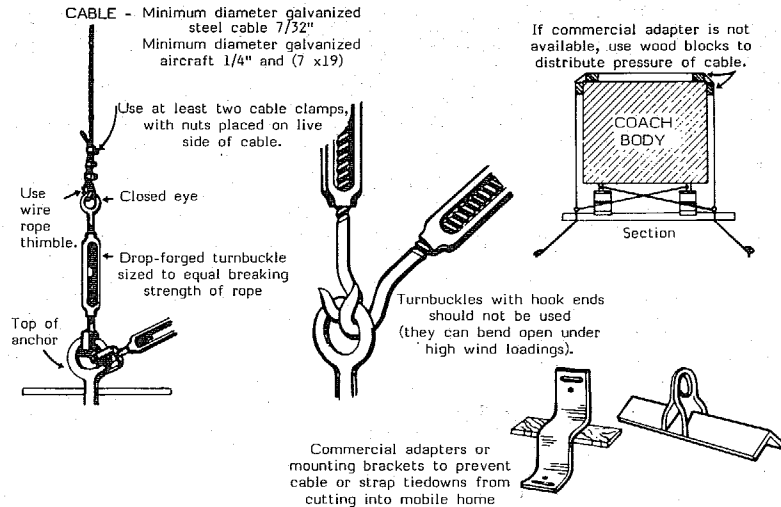
Fig. 6.14. Hardware for mobile home tiedowns. Modified from U.S. Civil Defense Preparedness Agency Publication TR-75.

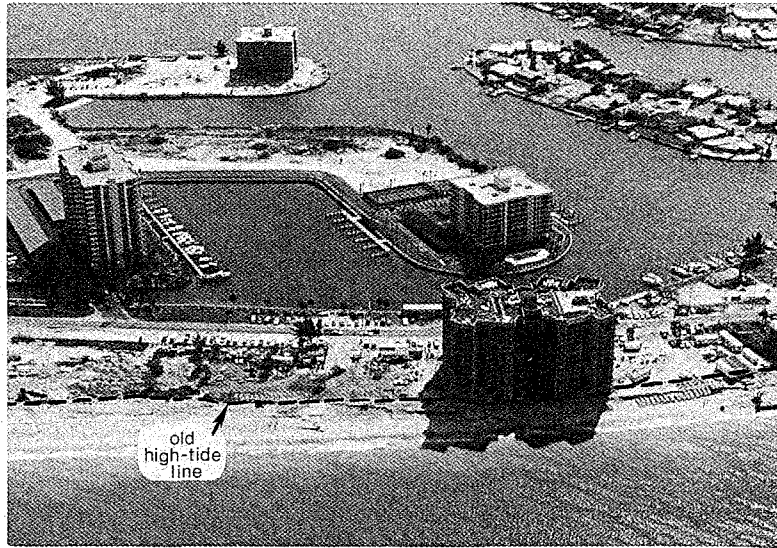
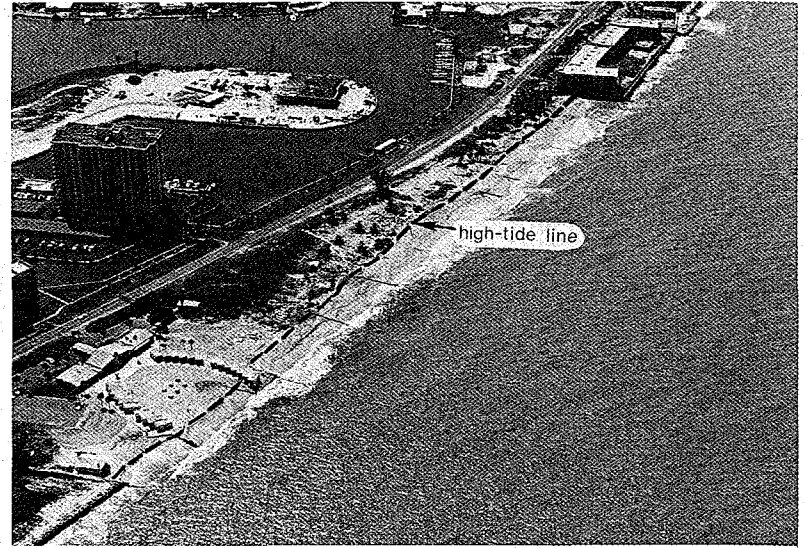
Fig. 7.1. This Pinellas County condo was built where the surf zone used to be! The developer violated the spirit of the construction setback law.

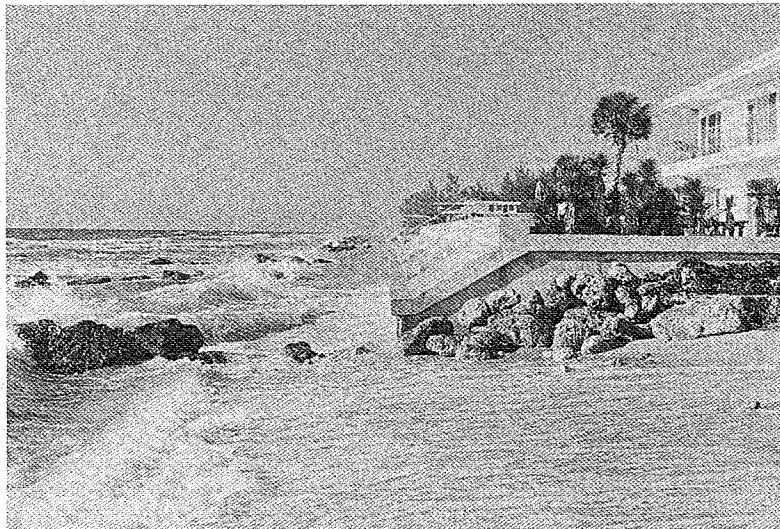
Fig. 7.2. A building located too close to the beach on Manasota Key is suffering the inevitable. Rock scattered about the beach reduces its recreational value. Photo by Dinesh Sharma.

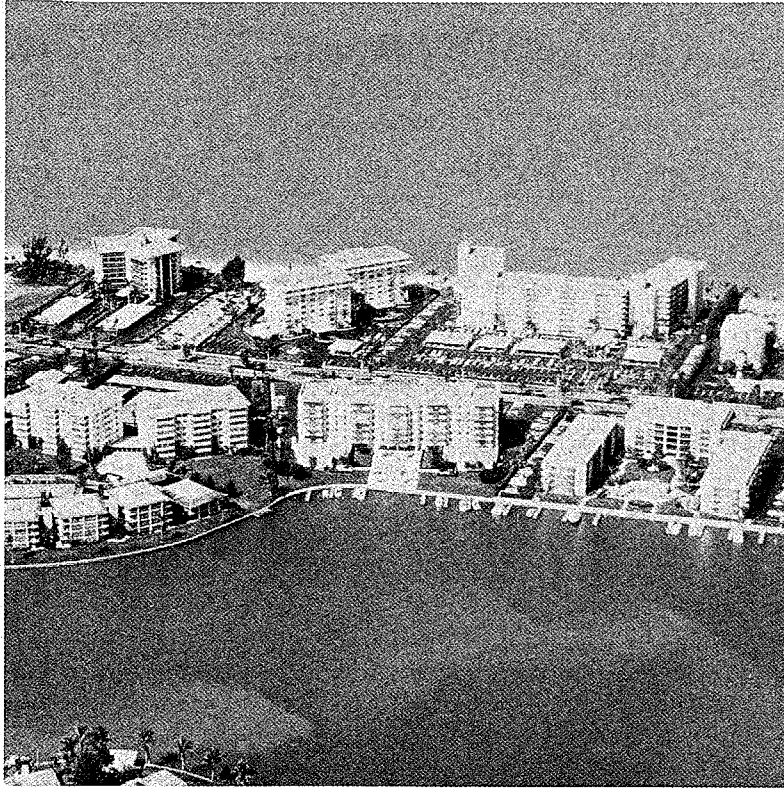
Fig. 7.3. Development crowding a narrow barrier island, Naples, Florida. Photo by Al Hine.

Most regulations do not prohibit development in high-hazard zones; they only set limits. The national Coastal Barrier Resources Act may deny flood insurance and federal funds for development of certain barrier islands, but it does not necessarily prohibit such development (see fig 7.3). The National Flood Insurance Program establishes a minimum standard for structural elevation in a flood zone to qualify for flood insurance, but generally it does not prohibit locating in such a flood zone. Similarly, state and local building codes set minimum standards.

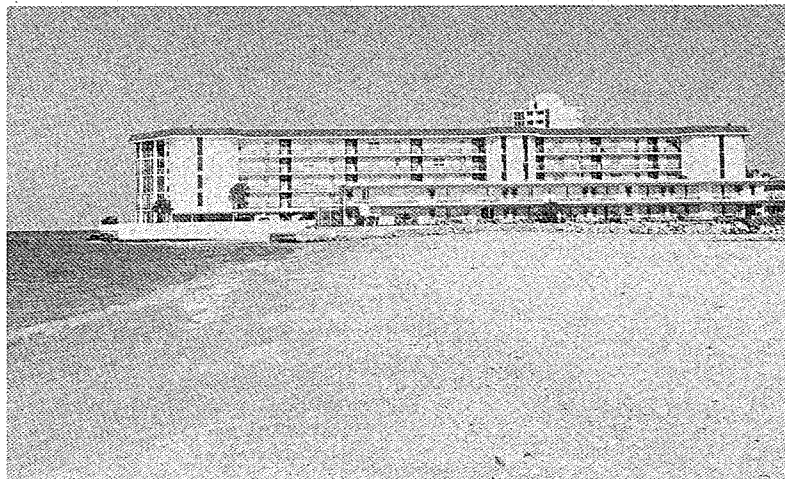
Fig. 7.4. A large building on Lido Key with a superb sea view. The view will likely become better and better as shoreline retreat continues, but in the next big storm. . . . Photo by Dinesh Sharma.

a result, many coastal communities in the state are seeking state and federally subsidized beach nourishment projects to protect the threatened properties. These “protective” projects are extremely costly to general taxpayers as well as to property owners, and are only *temporary* in nature. An effective CCCL program should limit the growth of such problems in the future, given *strict* interpretation and enforcement. Keep in mind also that there are no setback requirements for any structures located on nonsandy shorelines of the tidal areas. As explained in chapter 2, such areas also are experiencing significant erosion due to the sea-level rise and drowning of the coastline (see fig 7.4).
